## An Experimental Investigation of the Failure of a Stepped Composite Plate

Thesis by  
Steven C. Gortsema

In Partial Fulfillment of the Requirements for the Degree of  
Aeronautical Engineer

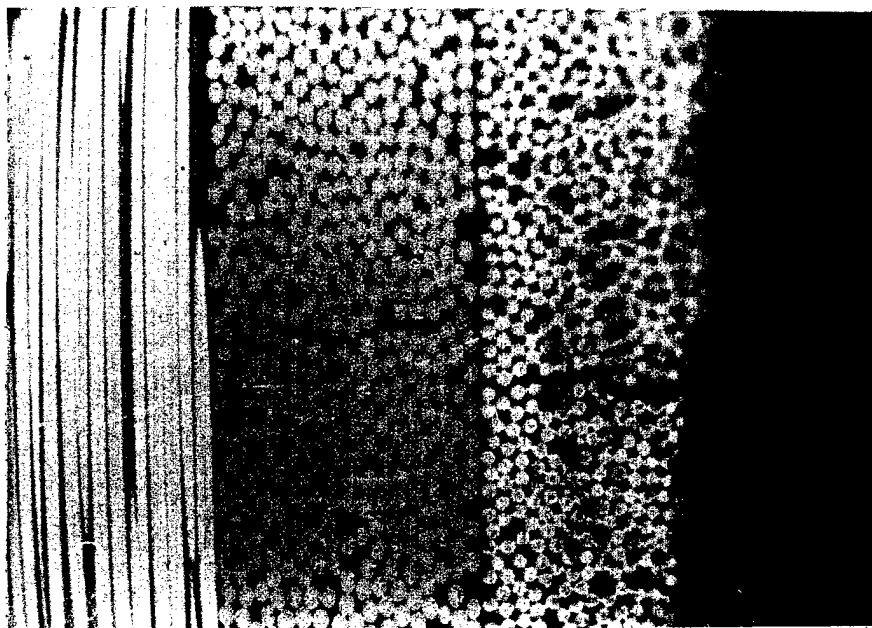
Figure 10d. Crack across the 90° plate interface ply and the 45° ply.

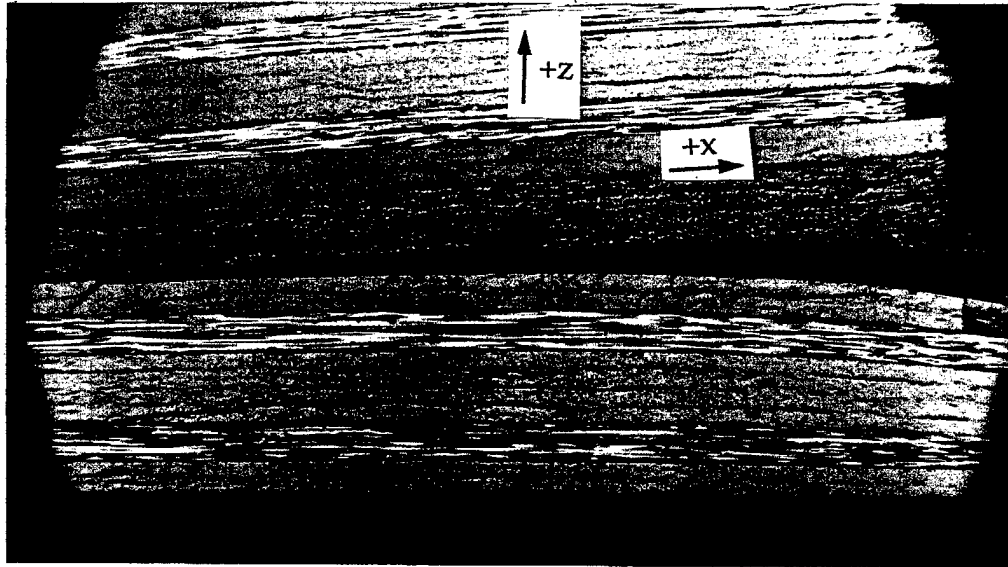
Figure 12f. Failed specimen.

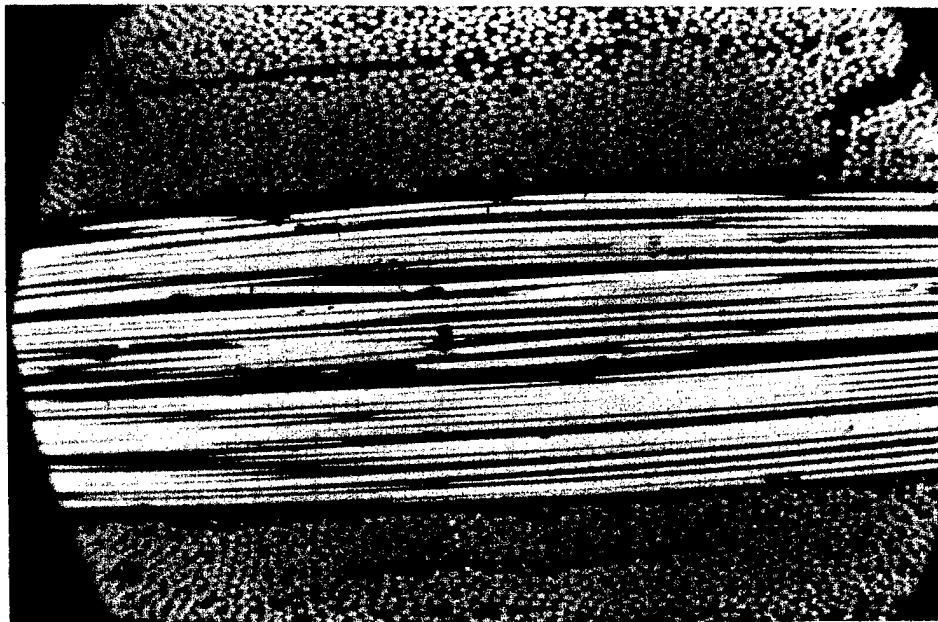
Figure 12g. Close-up of the region near the left of Figure 12f, where 45/0 delamination began.

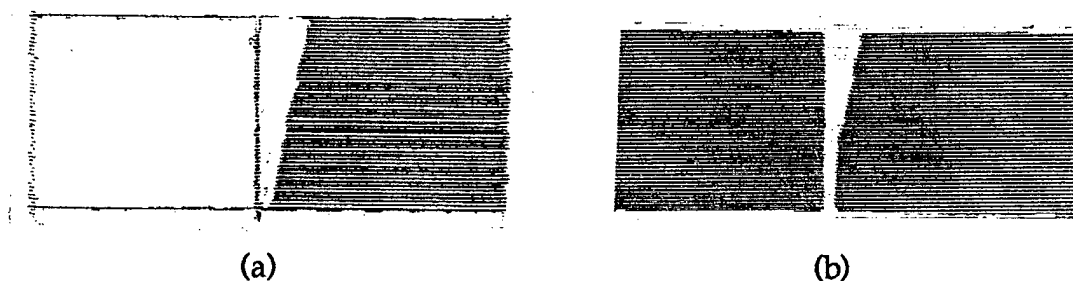
The above discussion has shown that the high peel stress caused by the beam shear force and the discontinuous change in bending stiffness can provide a stable means of driving the delamination crack forward. However, there are some other features about the delamination process that warrant further discussion. The crack-front propagation form shown in Figure 19 has been deduced by the author's interpretation of the C-scans shown in Figure 20.

Figure 20. C-scans of partially delaminated specimens.\*  
(a) Lay-up case 1. (b) Lay-up case 2.

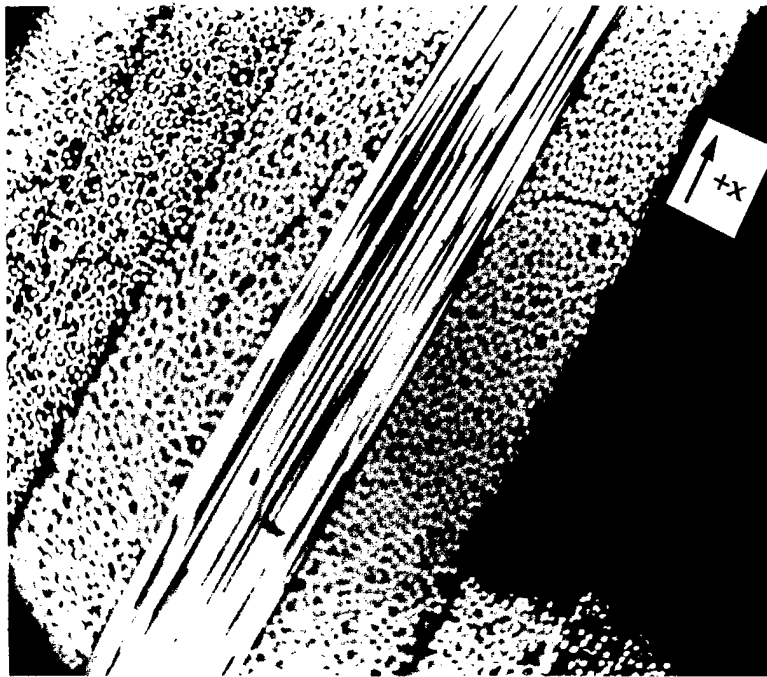
Figure 28a. First crack to appear on the positive edge.

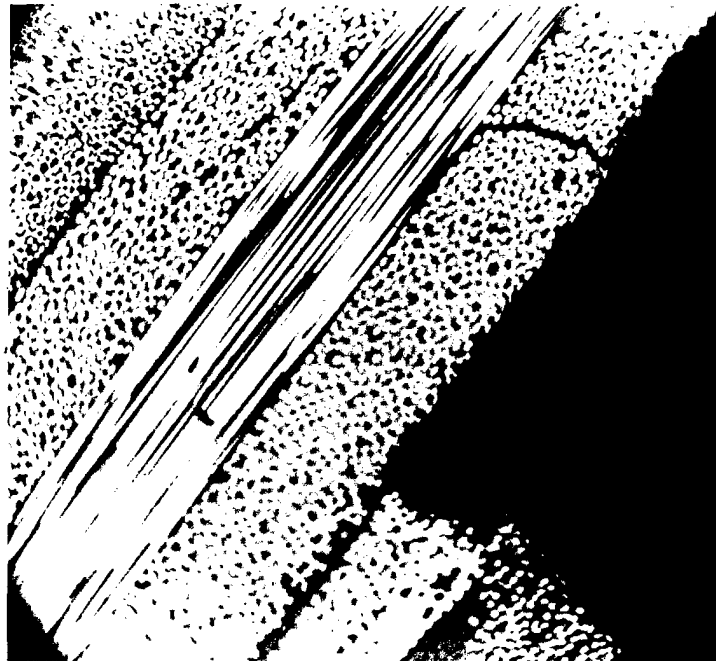
At approximately the same load,  $0^\circ$  fiber fractures are often observed ahead of the  $45^\circ$  ply crack nearest the corner (shown by "2B" in Figure 27). In some cases this crack even turns and begins to propagate stably in the  $-x$  direction along the  $45/0$  interface (Figure 28b).

Figure 28b. Stable propagation along the 45/0 interface.

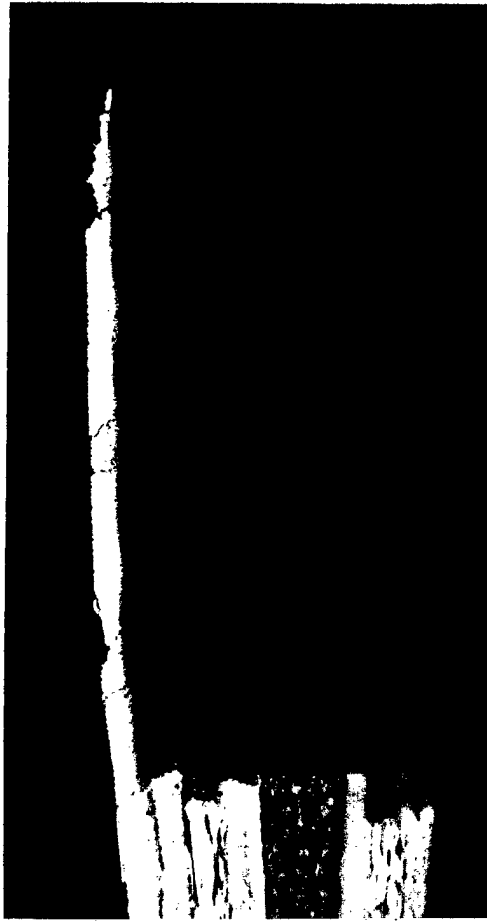
Figure 28c. Failed specimen.

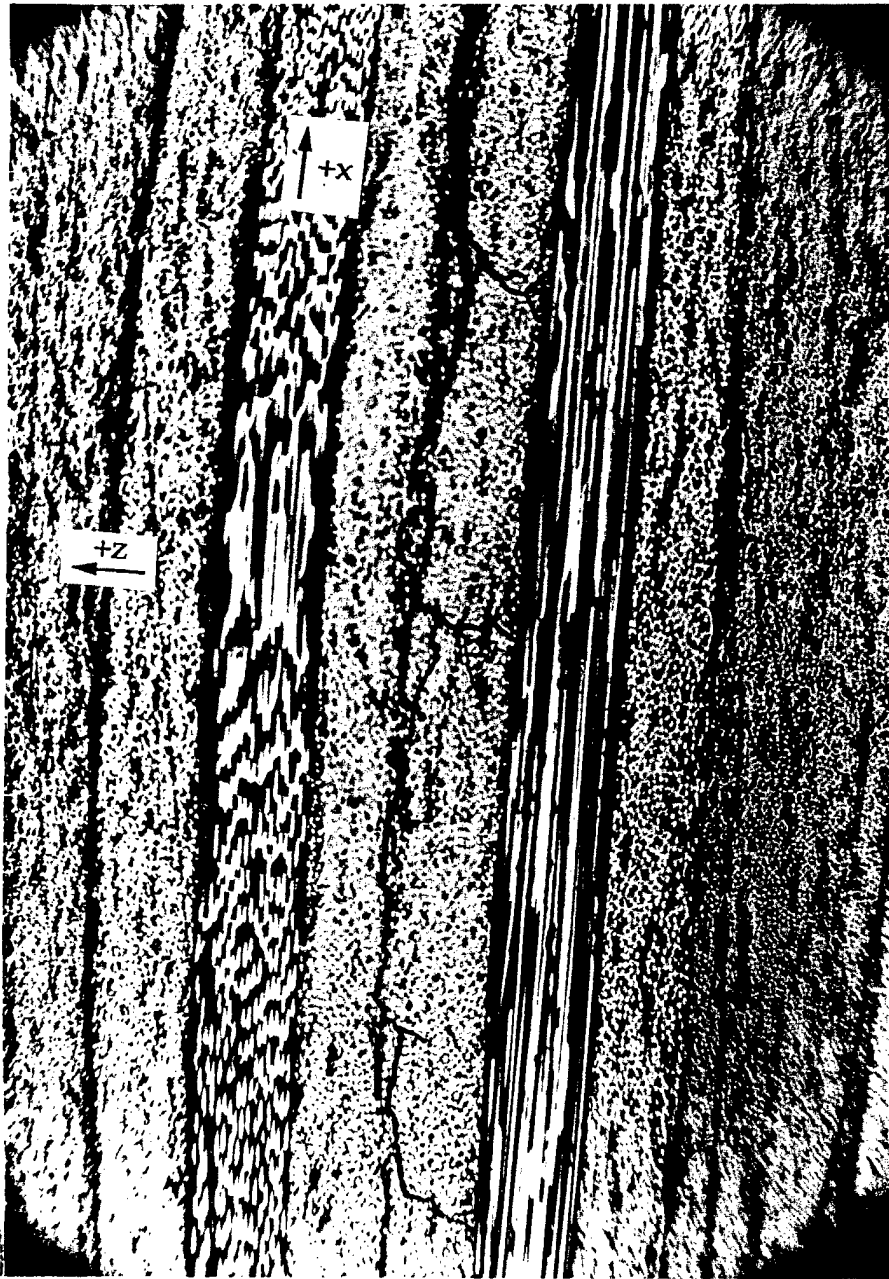
Figure 30.<sup>en</sup> Delamination propagation on the negative edge.
